# Hazard Assessment of Lithium Ion Battery Energy Storage Systems

*FINAL REPORT*

© February 2016 Fire Protection Research Foundation

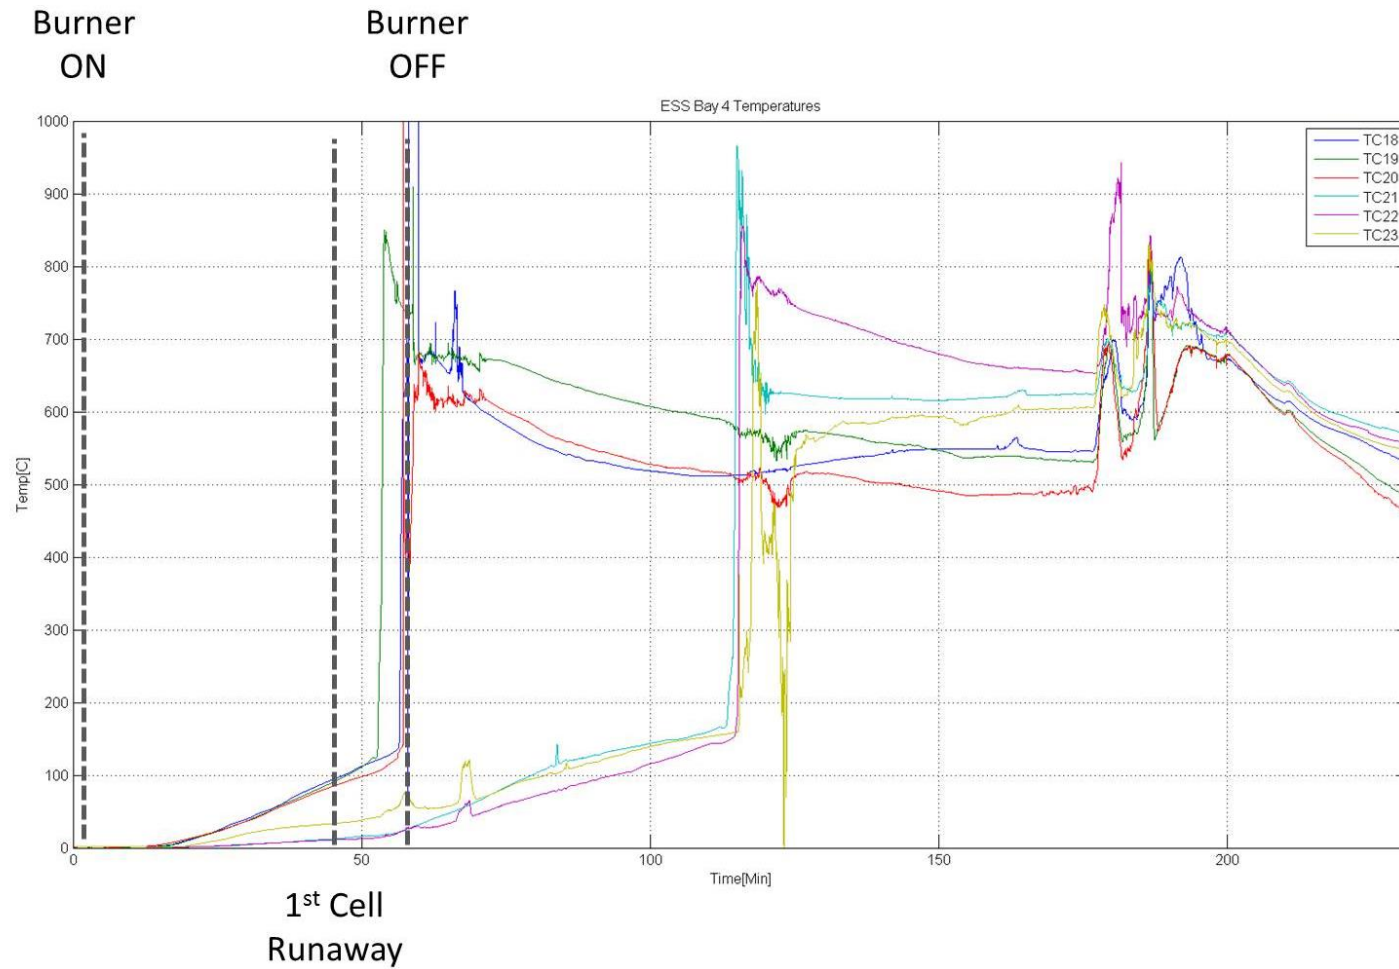
Figure 32 Powerpack Pod 4 temperatures (noise observed in the data is consistent with electrical interference that occurs during voltage leakage from the damaged batteries after thermal runaway)

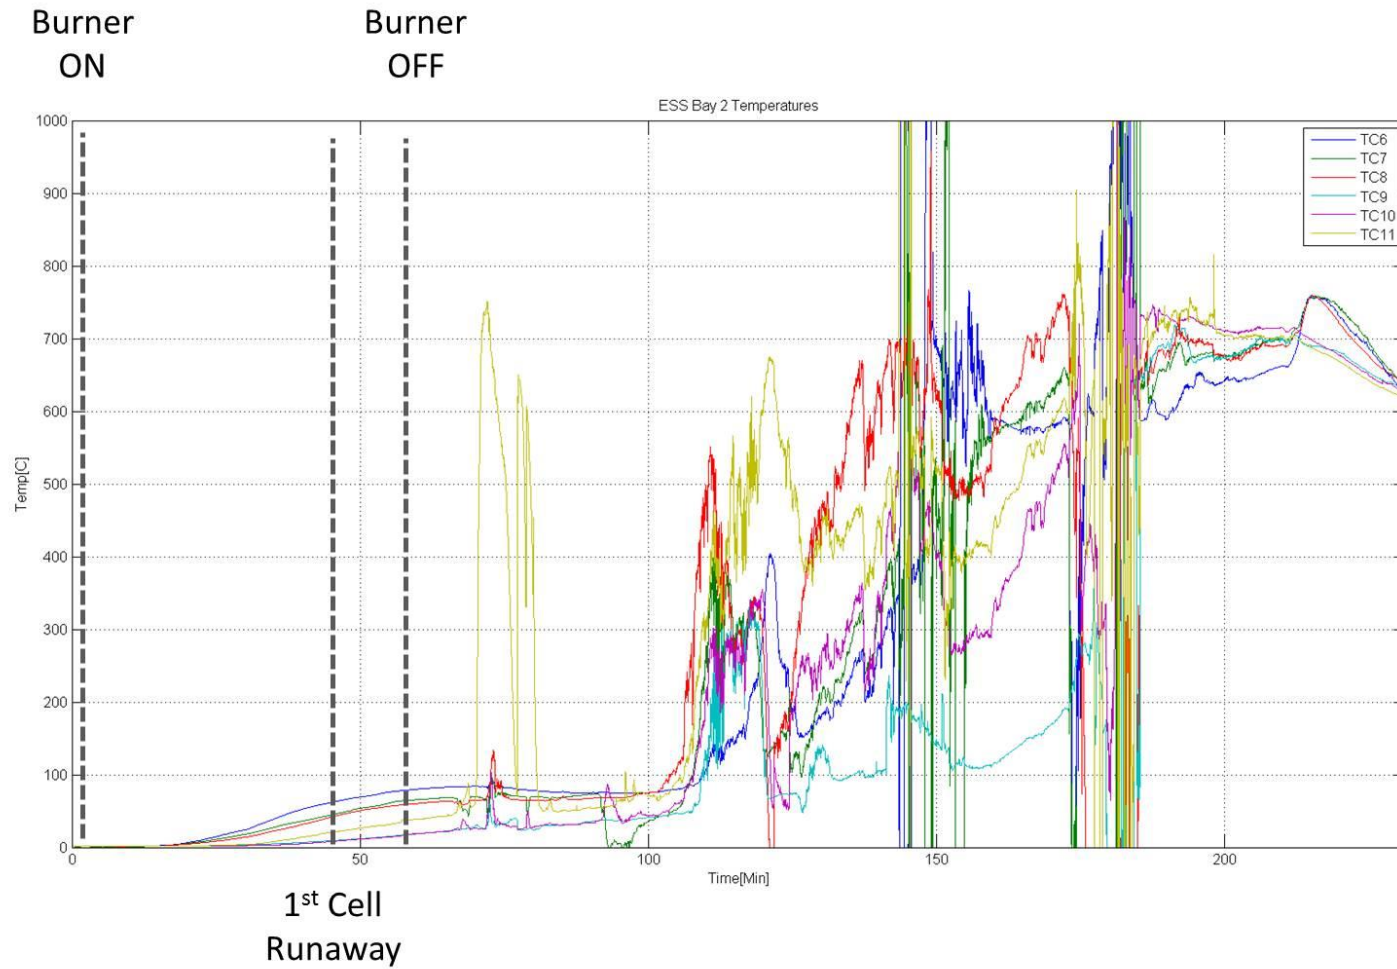
Figure 34 Powerpack Pod 2 temperatures (noise observed in the data is consistent with electrical interference that occurs during voltage leakage from the damaged batteries after thermal runaway)

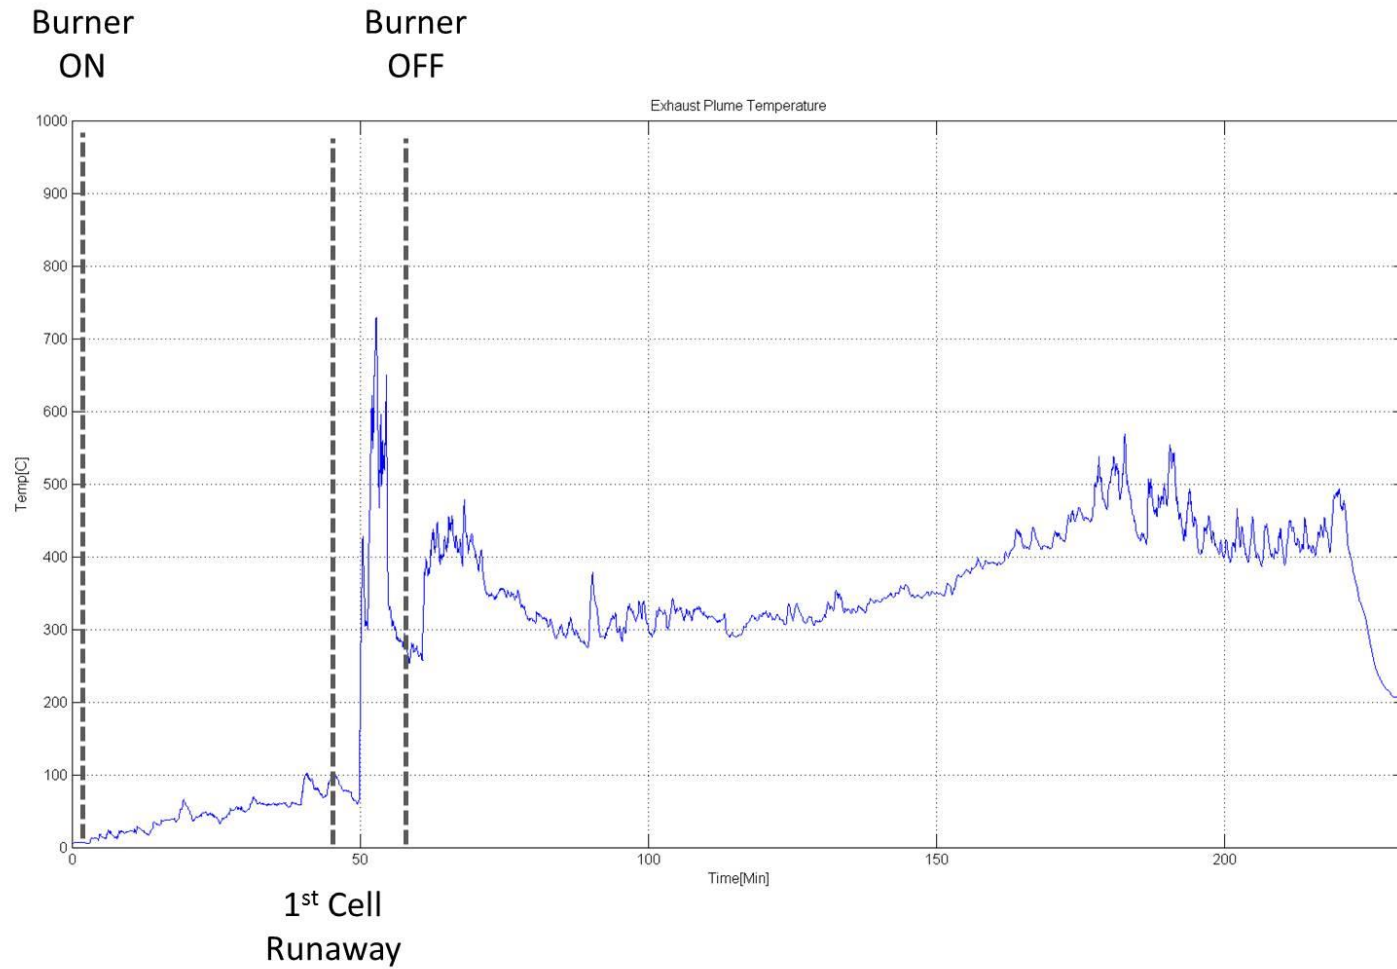
Figure 36 Powerpack exhaust vent temperature

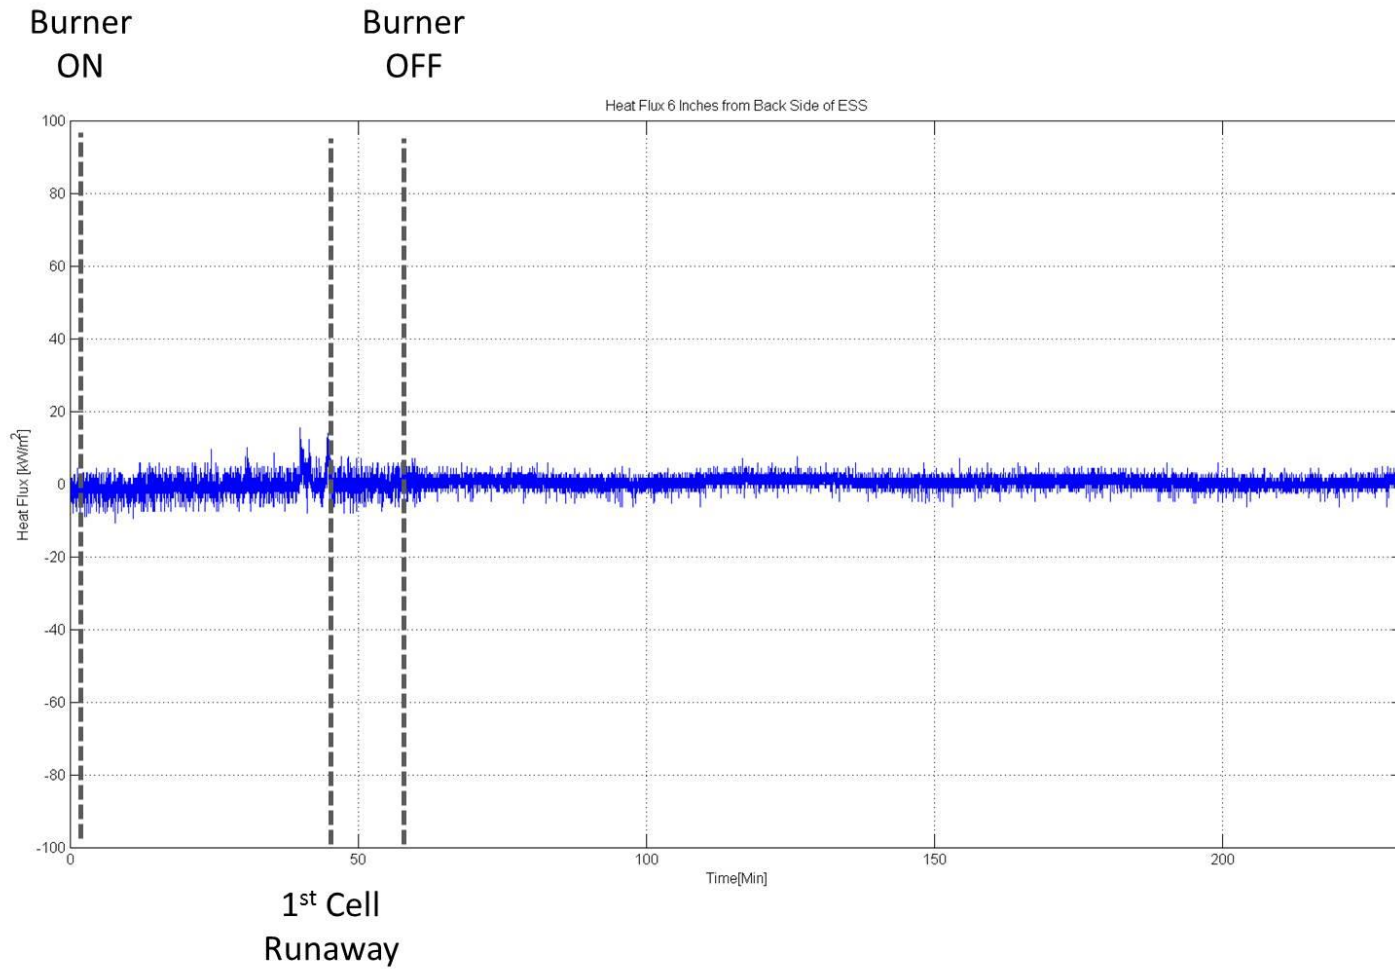
Figure 41 Heat flux measurements at HFG4, 6 inches from the side of the Powerpack

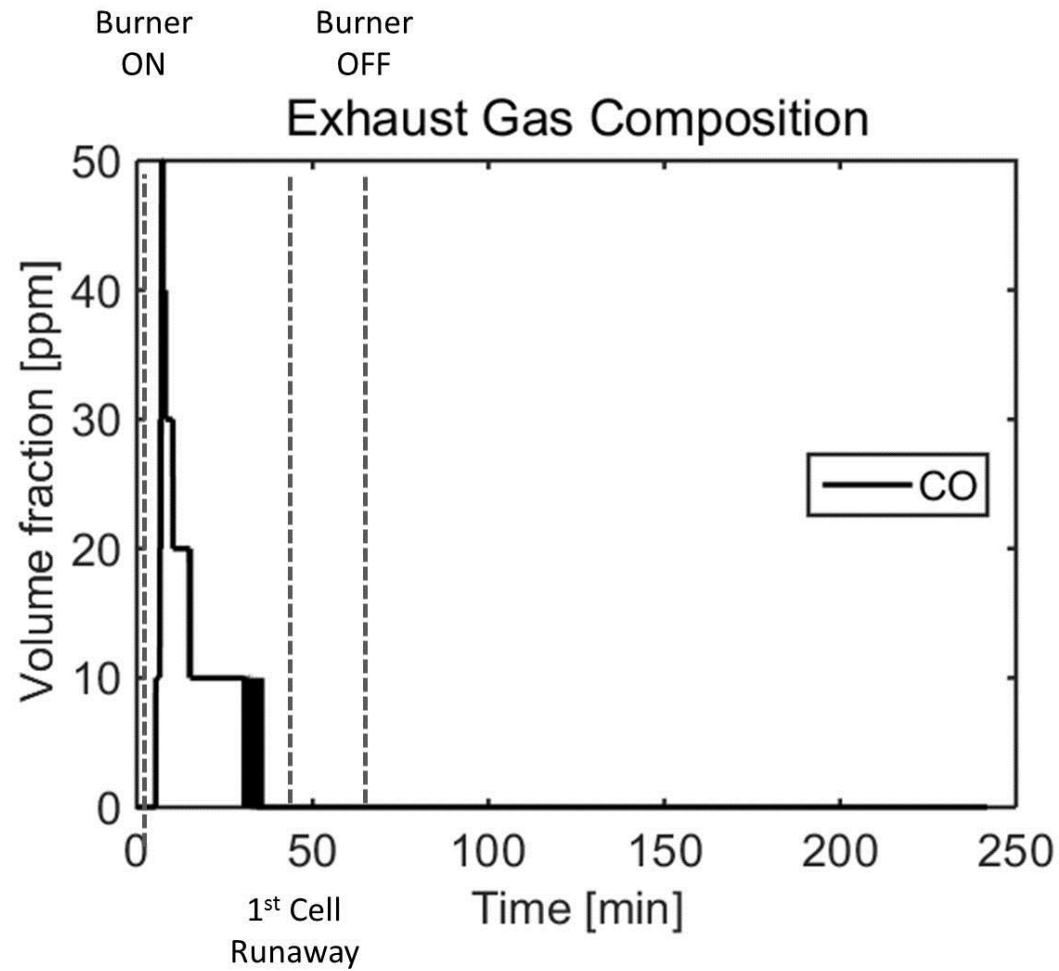
Figure 43 CO detected at the exhaust vent

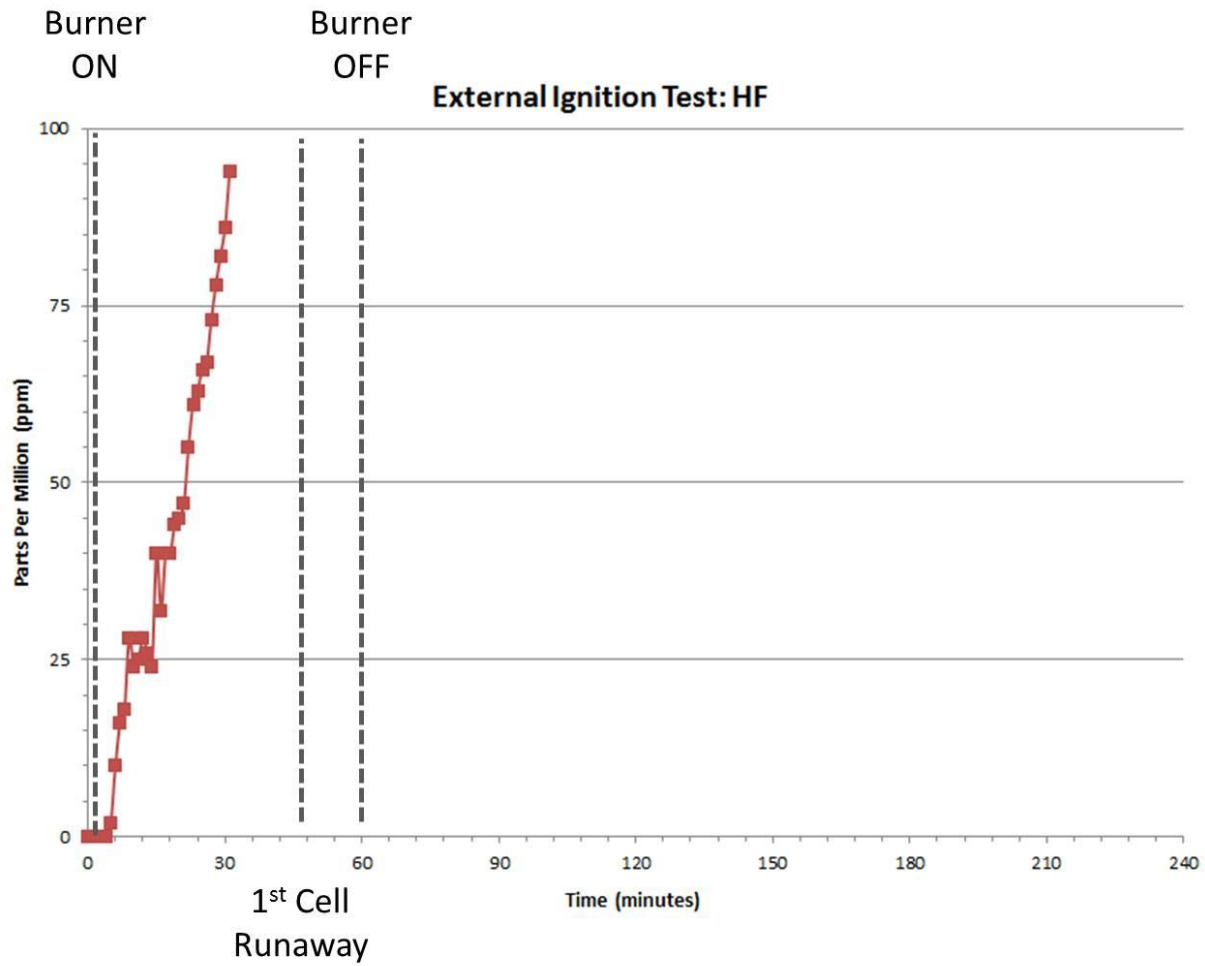
Figure 44 HF detected at the exhaust vent (detector maximum range was 100 ppm; all measurements after minute 30 were “over range,” indicating the HF values were greater than 100 ppm for the remainder of the test
